## Safety Bulletin 119

### Serious Incident Involving a MEWP

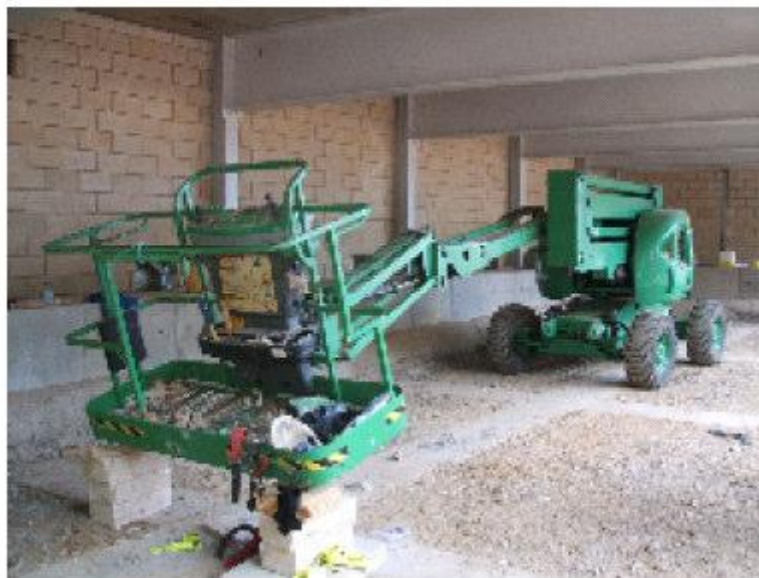
There has been a serious incident on a construction site involving a Mobile Elevated Working Platform (MEWP). A civil engineering operative was grouting up concrete from a MEWP basket inside the Gas Insulated Switchgear (GIS) building when he became trapped between one of the buildings structural beams and the control panel on the MEWP. The MEWP basket was lowered and the Injured Party was attended to by first aiders / occupational nurse. He was removed from the MEWP basket by paramedics with assistance of the local fire brigade.

Subject to the investigation being completed, with **immediate** effect all projects should reassess activities involving MEWPs, the following points need to be carefully considered:

- ✚ Select the most suitable type of working platform for the task to be conducted.
- ✚ Ensure the risk assessment for the activity identifies the hazards present such as ground conditions, adjacent structures, other working parties, etc.
- ✚ Operation of MEWP's must be controlled by a competent and non-working vehicle marshal at ground level.
- ✚ Are contingency arrangements in place should the MEWP basket be trapped in the raised position i.e. vehicle marshal trained on the emergency lowering procedure.
- ✚ Competence and supervision of personnel involved (CPCS or IPAF qualifications), including previous experience of similar operations and familiarisation of the equipment used.
- ✚ The working party must review hazards and controls measures daily.
