## Safety Bulletin 122

### Safety alert – podium steps collapse

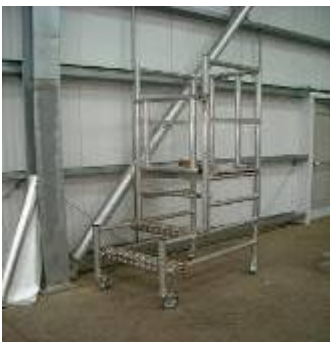
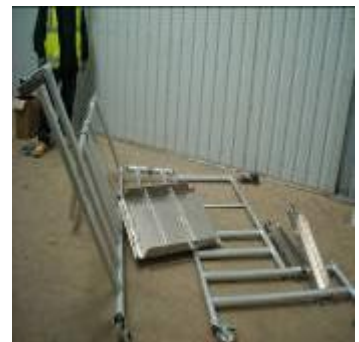
An electrical sub-contractor was installing a length of conduit over a door way from a set of podium steps. The steps collapsed and the electrician fell heavily, sustaining a fractured wrist.

Investigation is continuing but it appears that the podium steps were not set up correctly. This may have reduced their stability, leading to collapse.

- ✚ Work at height should be avoided if possible
- ✚ If unavoidable, it must be planned (risk assessment) and suitable equipment (not too long or too short) used
- ✚ Inspect access equipment for obvious damage before use - if damaged, quarantine it and label “do not use”
- ✚ Correctly assemble and use equipment only in accordance with manufacturers instructions
- ✚ Avoid over reaching or leaning over any safety barriers fitted to the access equipment or work platform - if you can't reach, get down off the equipment and move it to a better position before recommencing work
