C J T Services Ltd

Safety Bulletin 86

Scissor Lift Failure

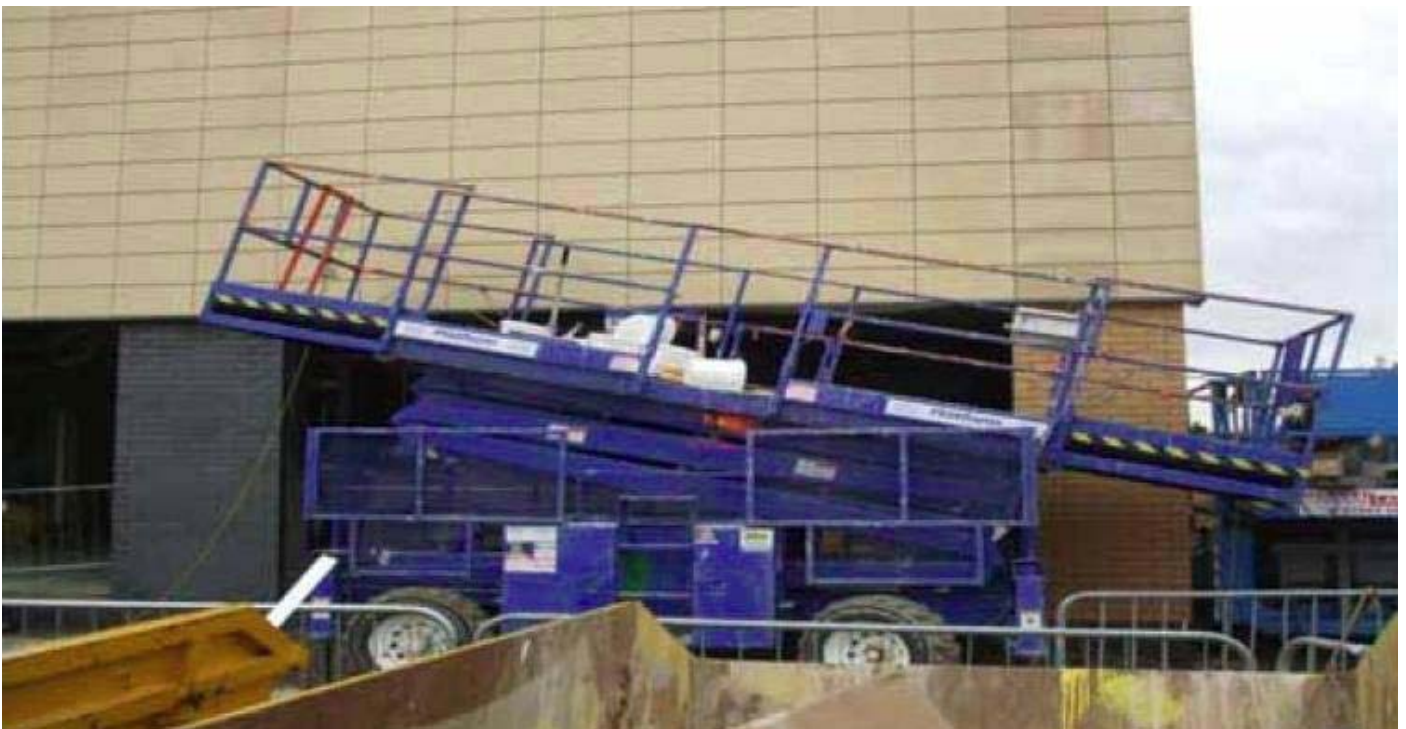
An incident recently occurred involving a **1999 model SKYJACK TYPE 8841 SCISSOR LIFT Mobile Elevated Working Platform (MEWP)**. The MEWP was being raised from its base position with two men on board when a noise was heard and the machine was stopped. Those on board and a third workmate observing at ground level looked for any obstruction etc. Having found nothing they attempted to continue to raise the platform when a loud bang was heard, at the same time the front end collapsed into the position shown below.

Fortunately the working platform had been raised less than 2 meters at the time and although the operatives were pitched forward, they were not seriously hurt and were able to climb down to ground level.

1. All examples of the SKYJACK 8841 model of MEWP should be identified and taken out of service immediately, pending inspection by an authorised engineer and written confirmation from the owner or supplier of being fit for use.

2. All other scissor lifts used should be subject to an inspection, paying particular attention to scissor arm base connections prior to further use. Inspection being undertaken by a competent operator and findings recorded. Should there be any cause for concern identified; the MEWP is to be taken out of service, pending a thorough examination to be arranged by the owner or supplier of the equipment.

3. Operators and users of scissor MEWPS are to be given a toolbox talk based on this bulletin, emphasising the importance of diligently undertaking their daily checks and weekly inspections in accordance with manufacturer's instructions, together with remaining alert to any developing fault or deterioration. **If in any doubt, take the machine out of service and report this to site management.**

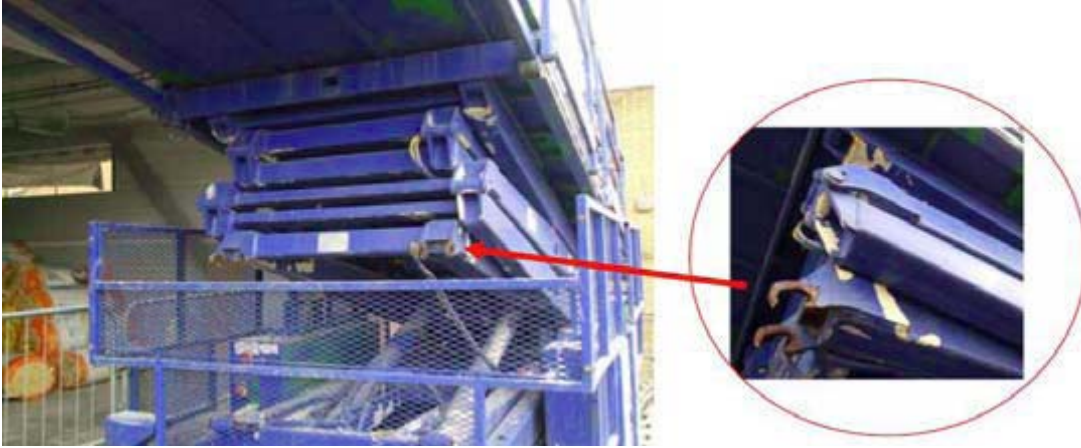
The rear end of the scissor packs' scissor arms had sheared from their base pivot-pin connectors as shown below, the close up shows one of these two failures.

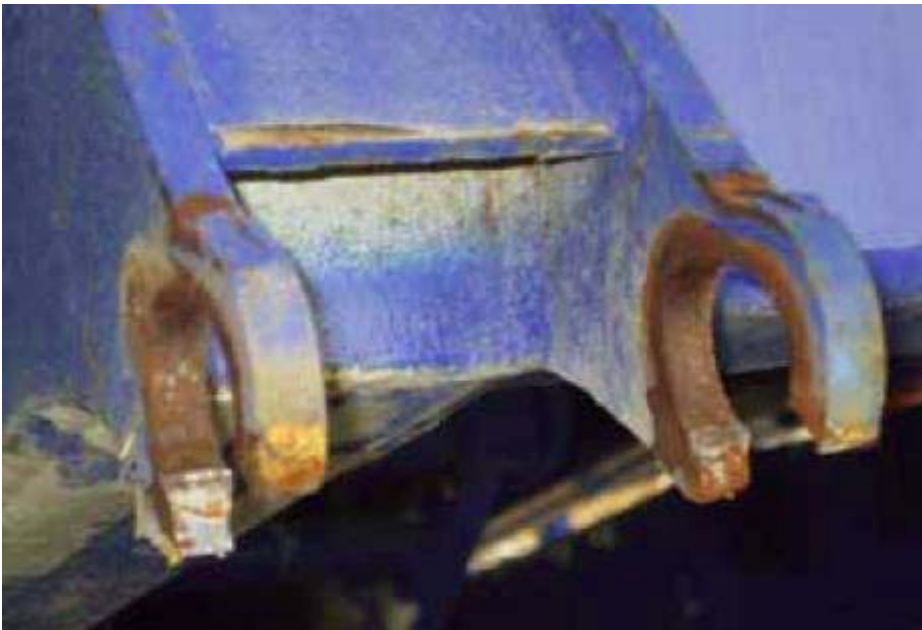
Initial examination identified oxidization, a suggestion of developing fatigue and final stress fractures as shown below.
