## Safety Bulletin 120

### Diamond Cutting Blade Failure Incident

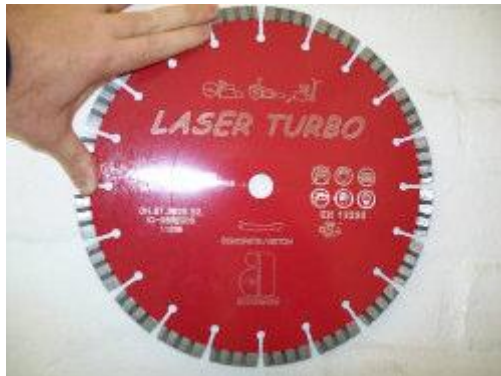
There has been a significant near miss involving a “Stihl” saw fitted with a new diamond tipped cutting blade on a training course. The saw was being used under supervision to cut a concrete pipe when the fins of the blade shattered. No one was injured; however, the incident could have had far more serious consequences. The saw was fitted with an Adamas Laser Turbo 12” diamond tipped cutting blade (see photograph below).

#### Product Information

Type = Adamas Laser Turbo

Size = 12in

Material use = Concrete

A full investigation is currently being conducted to identify the root cause of the blade failure. However, Site Managers and Safety Officers are requested to undertake an inspection of any “Stihl” type saws and stocks of blades on site.

Where Adamas Laser Turbo diamond tipped blades are identified, these should be quarantined and clearly marked “Do Not Use”. Replacement blades should be sourced from an alternative manufacturer. The salient points of this safety note are advised to be delivered via a tool box talk to all site personnel engaged in the use of hand held “Stihl” type saws.
